HUNTER VALLEY OPERATIONS

2022 ANNUAL ENVIRONMENTAL REVIEW

DOCUMENT NUMBER
HVOOC-748212775-6

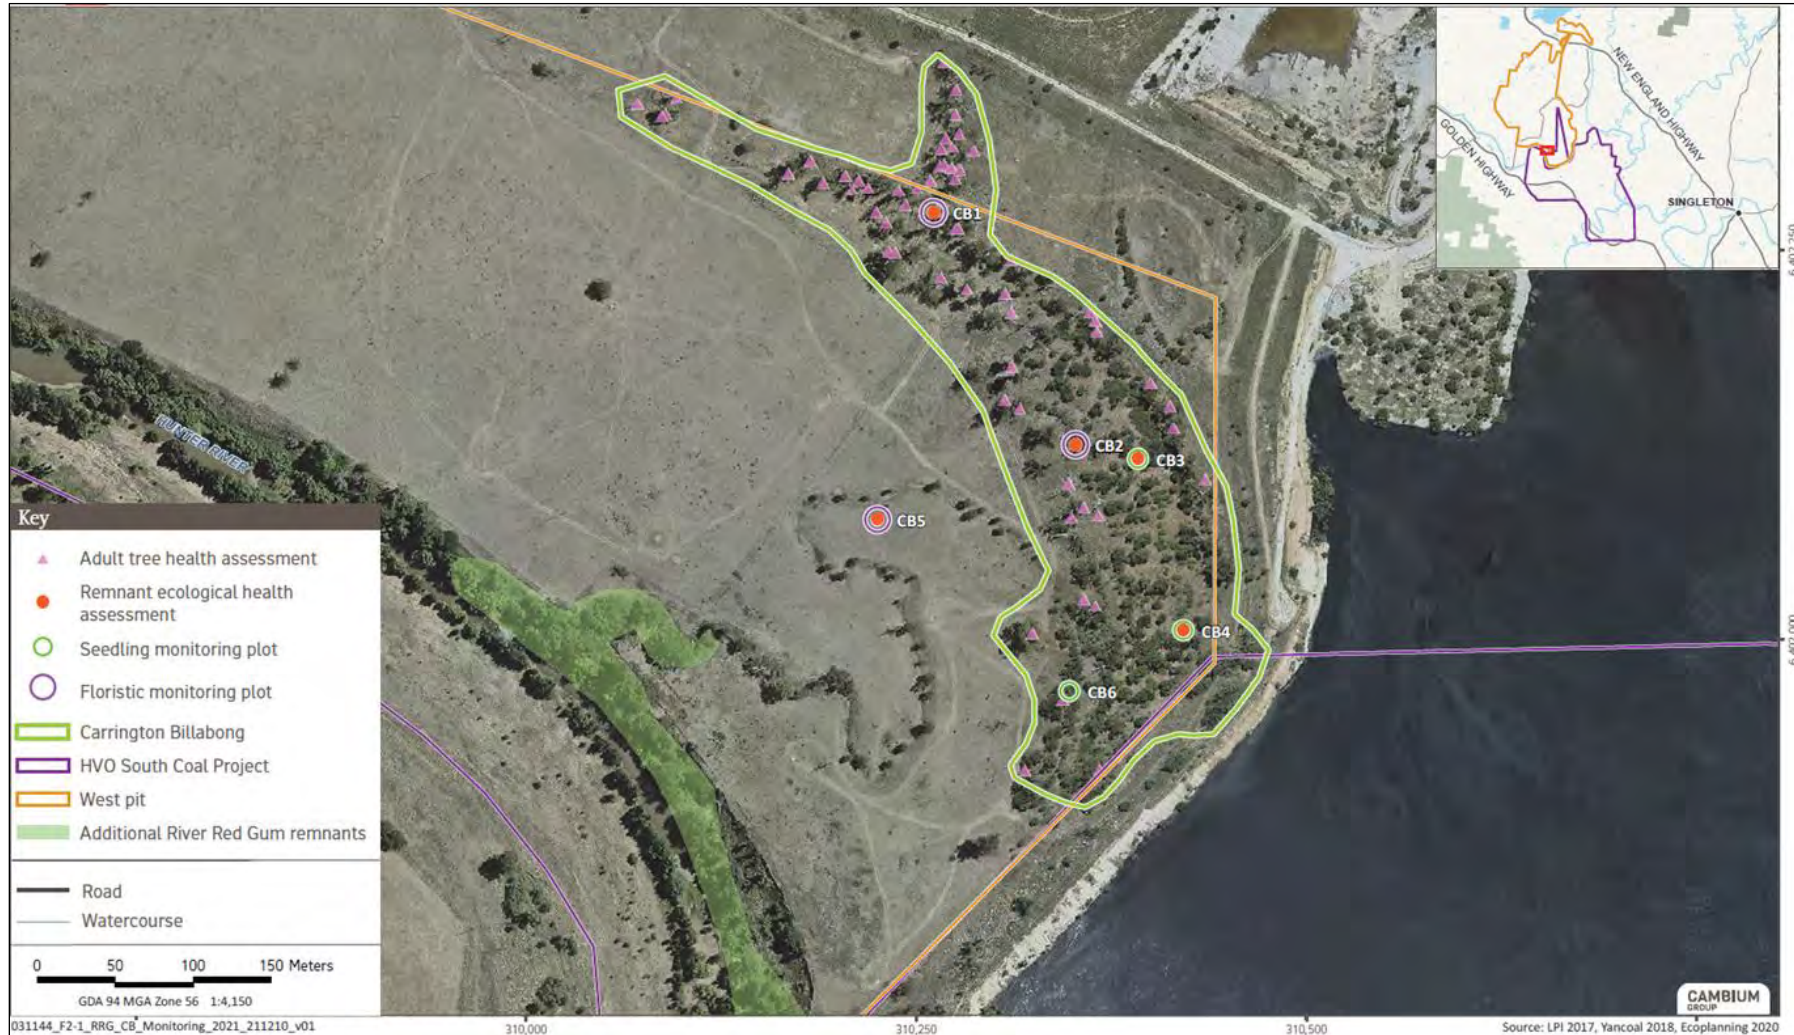
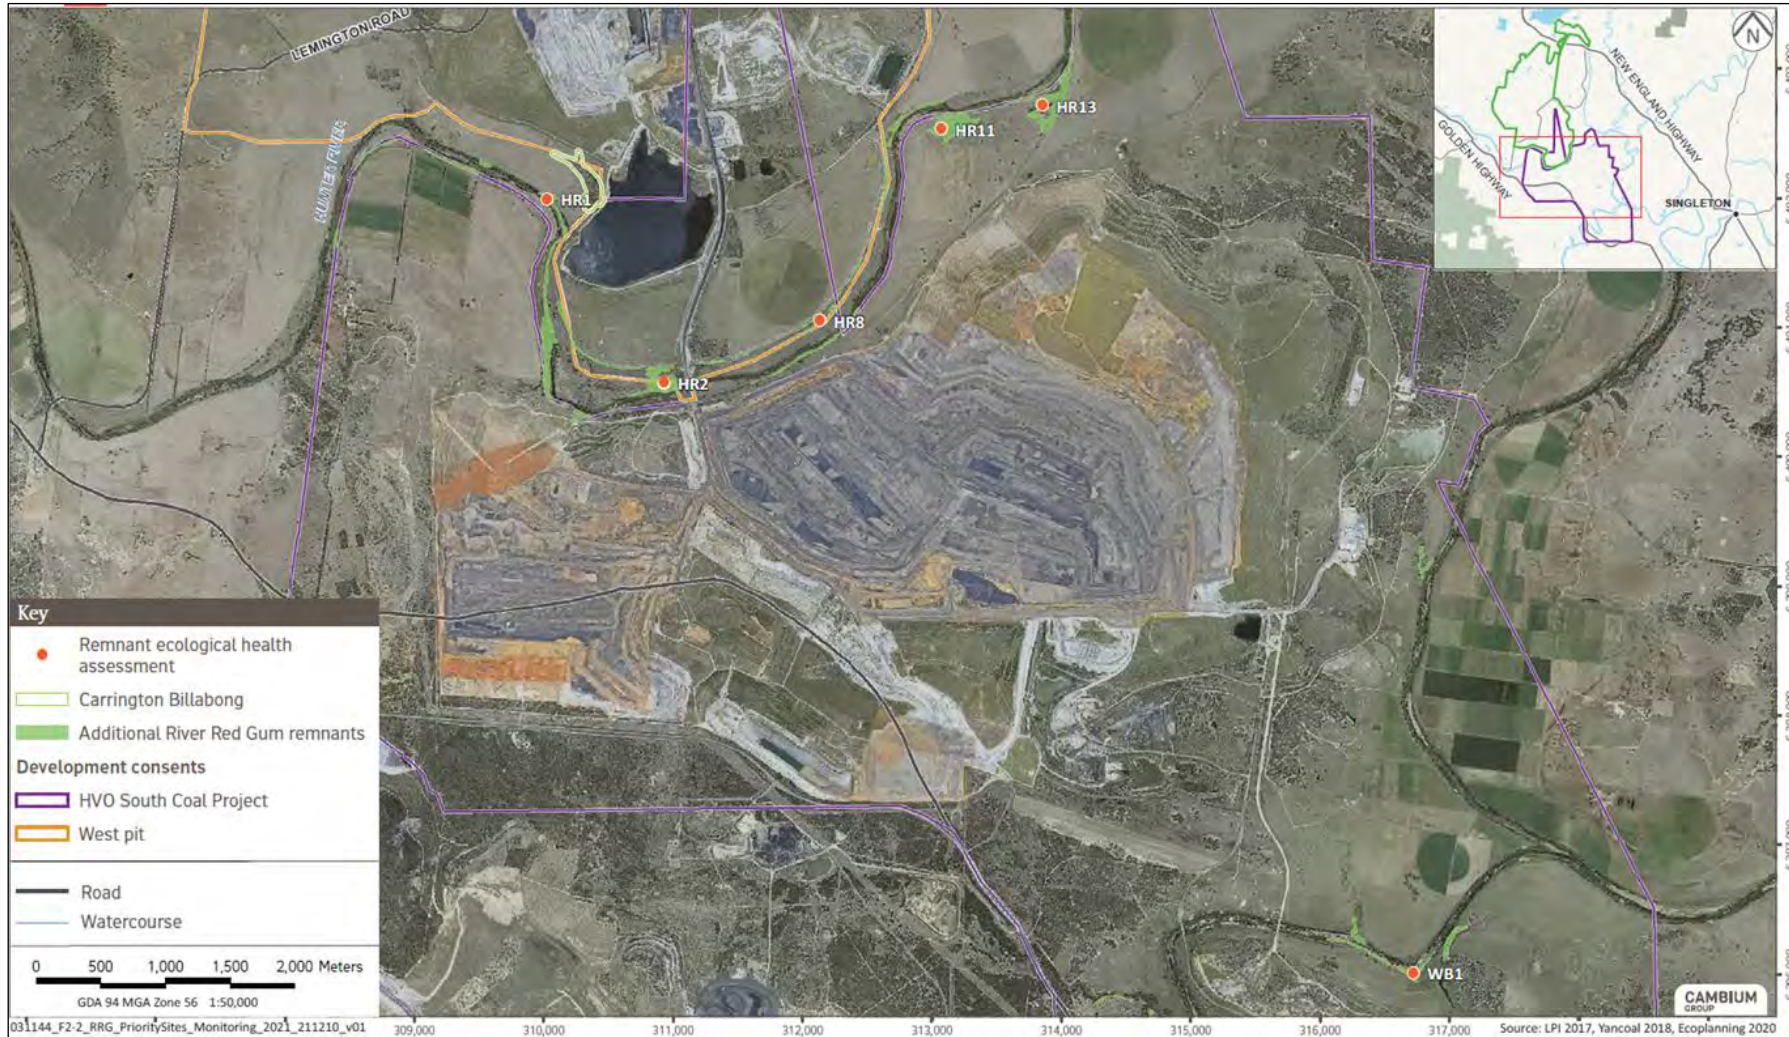
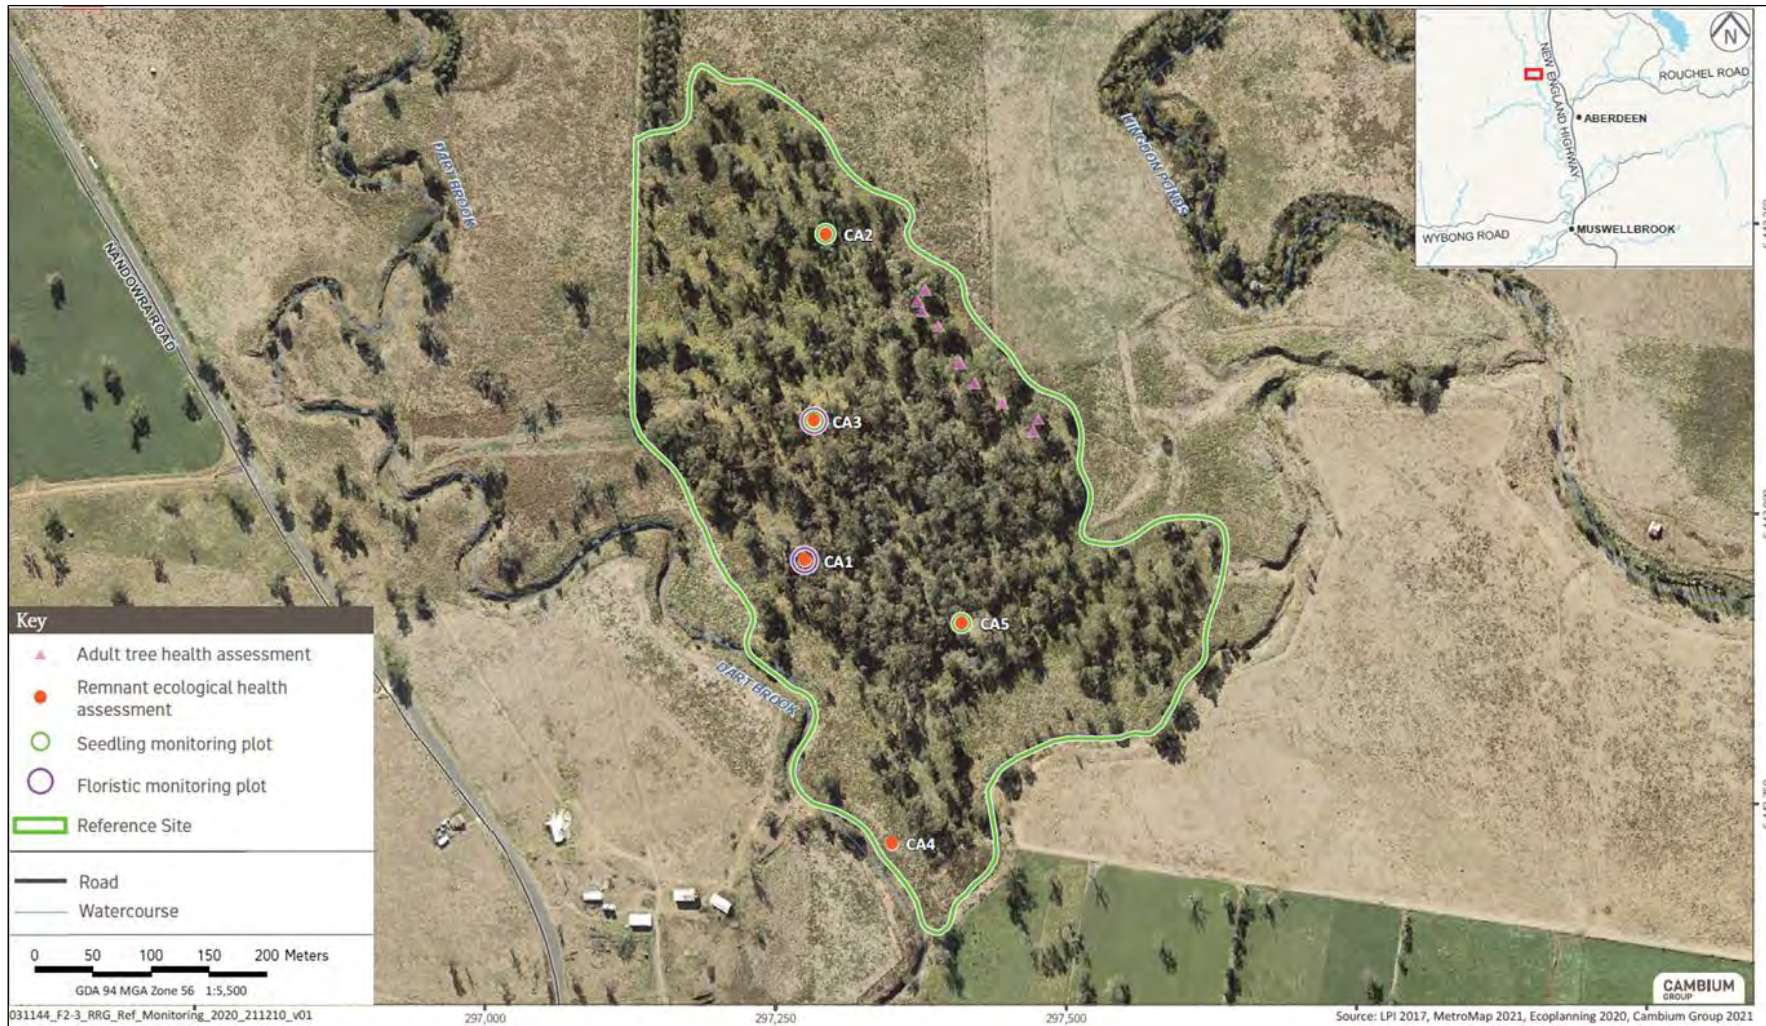
Figure 8-11: *Eucalyptus camaldulensis* monitoring sites at Carrington billabong.

Figure 8-12: *Eucalyptus camaldulensis* priority site monitoring locations

Figure 8-13: *Eucalyptus camaldulensis* monitoring locations at the Reference Sites

Ecological monitoring occurred in 2022. The locations of the sampling points are shown in **Figure 8-11** to **Figure 8-13**. Flooding within the Reference Site prevented monitoring from occurring and thus the monitoring results discussed below relate only to the HVO sites.

The priority sites shown in Figure 8-12 were also sprayed and/or slashed during 2022 along with extended areas of the Hunter River immediately adjacent to the priority RRG stands.

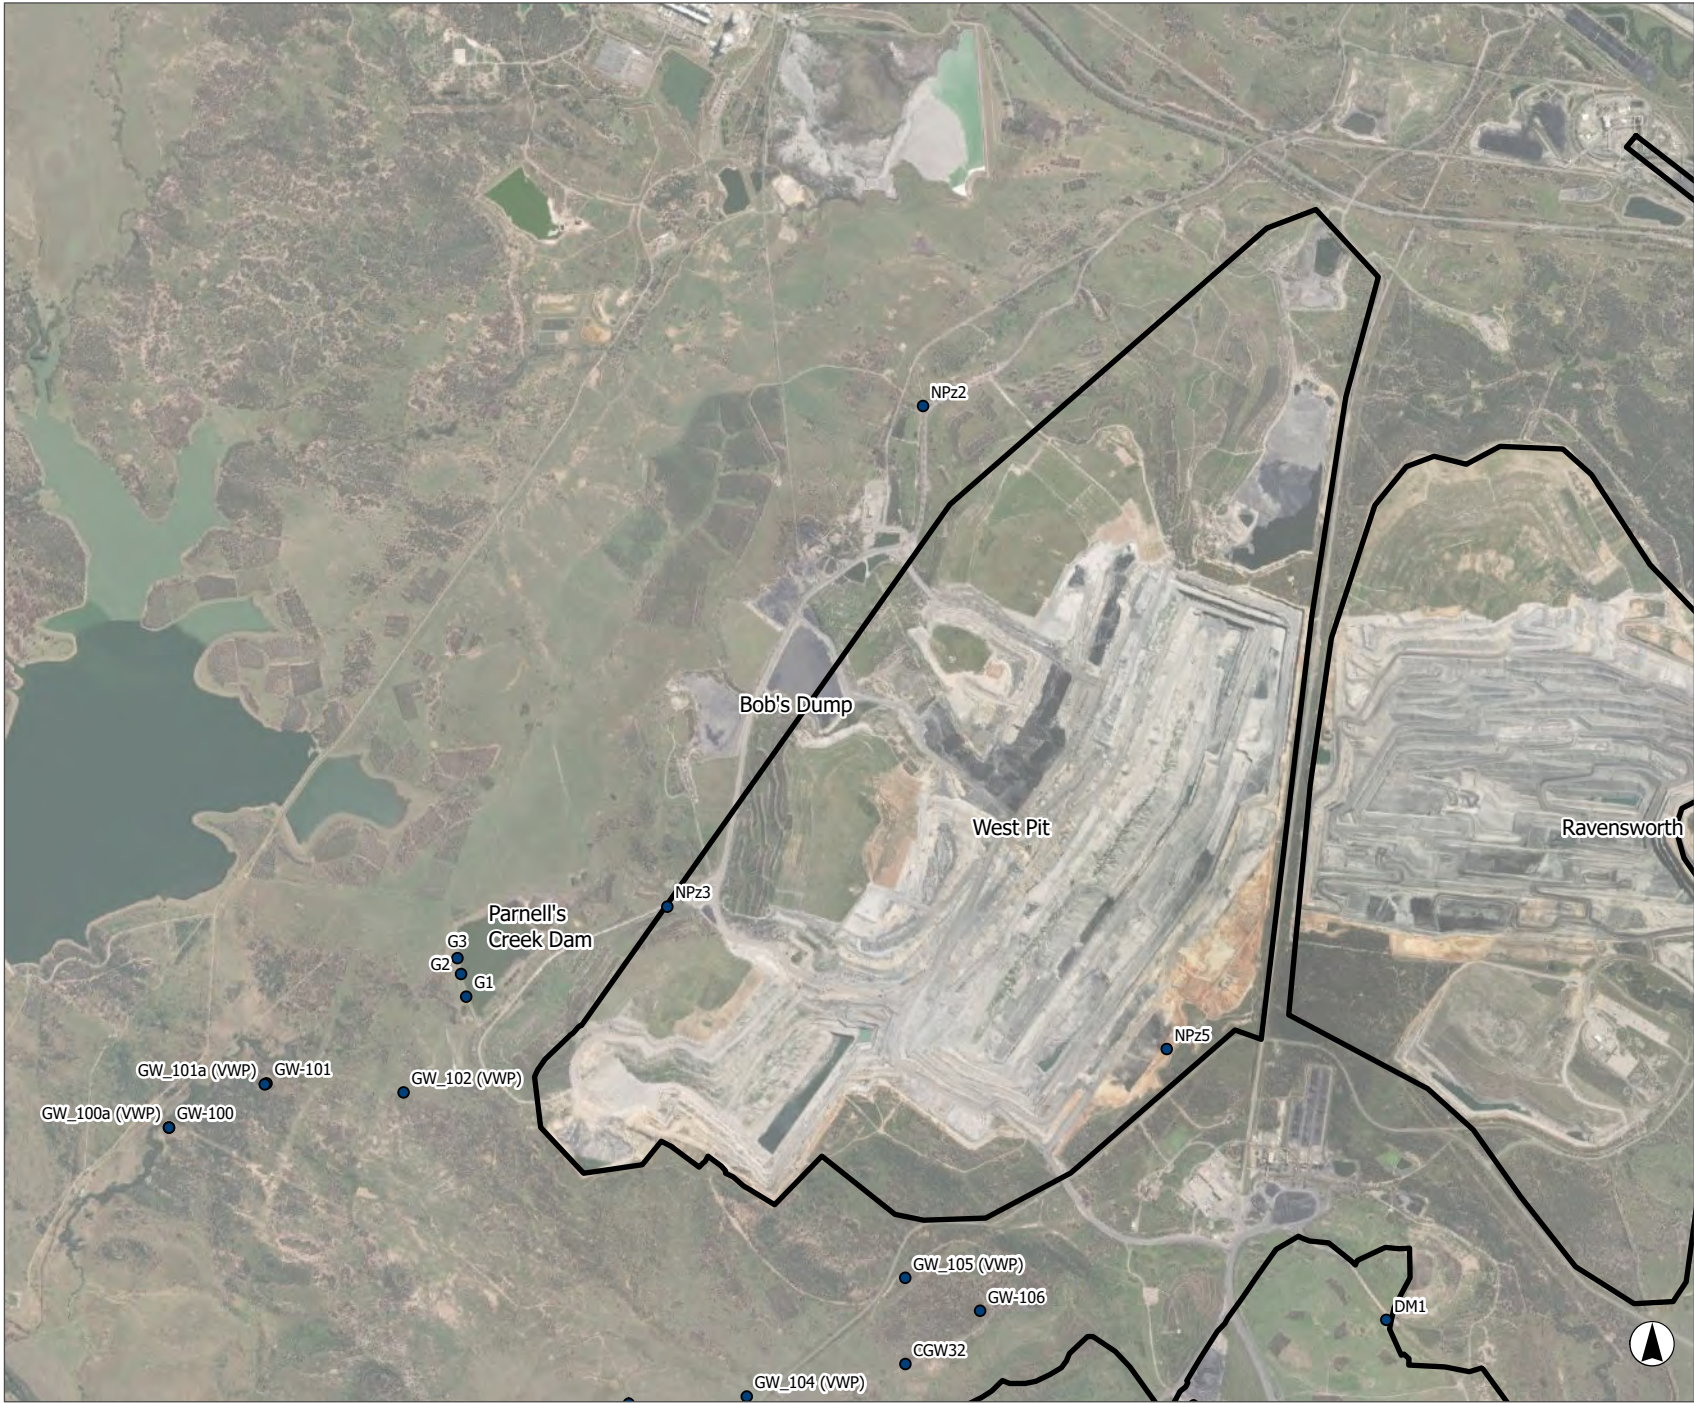
FIGURE 4.1

Groundwater Monitoring Network – HVO North: West Pit

The groundwater monitoring network at HVO is comprised of a series of monitoring bores and vibrating wire piezometers (VWPs), detailed in **Appendix A**. The groundwater monitoring network, outlined within the WMP, is comprised of 127 monitoring sites which includes 119 compliance monitoring bores and eight vibrating wire piezometers (VWPs), as detailed in **Table 4.1**. Of the 119 compliance monitoring bores, 104 have water quality triggers and five have water level triggers defined. The groundwater monitoring network is presented in **Figure 4.1** to **Figure 4.3**.

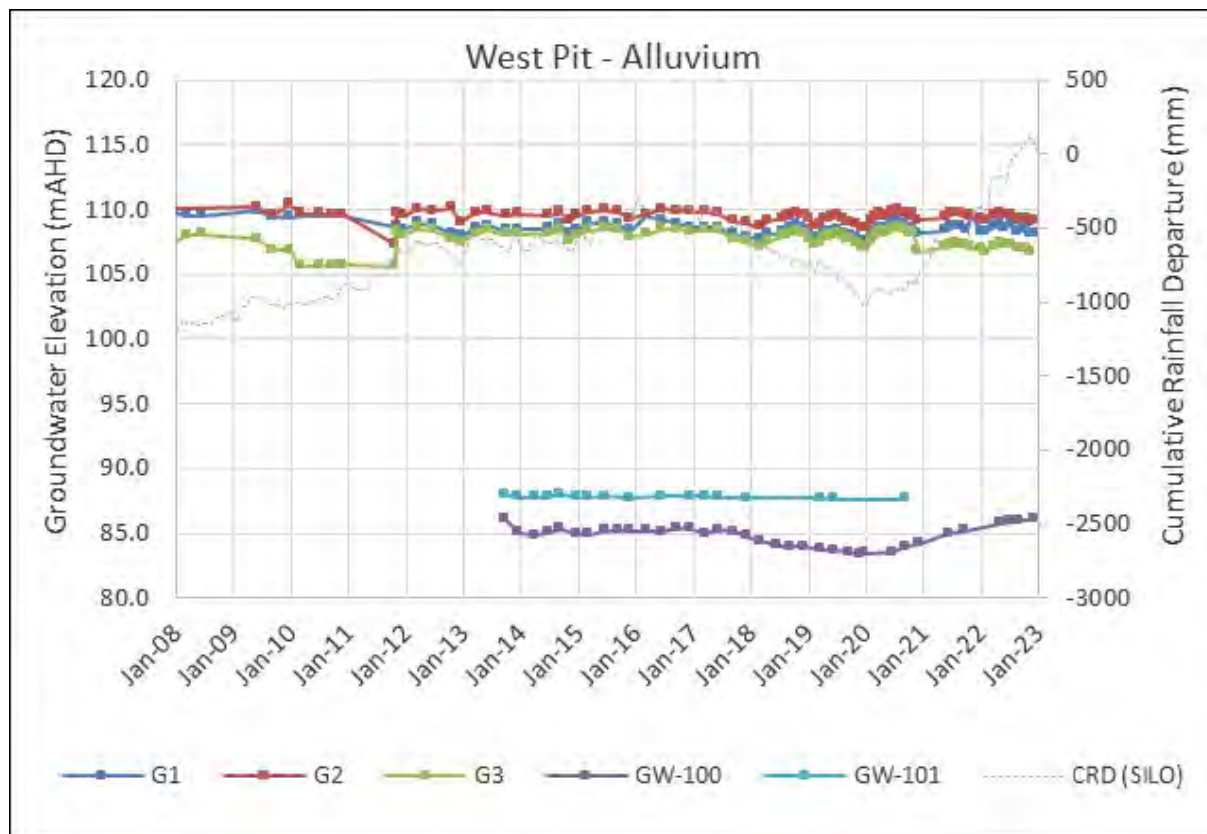
Groundwater levels for the five alluvial/regolith bores north and north-west of West Pit are presented in **Figure 5.1**. Over 2022 groundwater elevations within the three bores (G1, G2 and G3) on the south-western side of Parnell's Creek Dam ranged between 106.69 mAHD (1.91 mbgl) and 109.68 mAHD (0.92 mbgl), in bores G3 and G2, respectively. Groundwater levels remained relatively stable over 2022.

Bores GW-100 and GW-101 are located along Parnell's Creek, downslope of the dam (18W). Groundwater levels within bore GW-100 increased slightly over 2022. Review of the bore construction log indicates GW-100 is 6 m deep and has a screen from 4.4 m to 5 m below surface within gravels (colluvial deposit). Groundwater levels within bore GW-100 show a general decline since 2015 from 4.68 m below top of casing (TOC) to 6.21 mbTOC near the base of the bore in December 2019. Groundwater levels increased from January 2020 to 3.56 mbTOC in December 2022 in response to above average rainfall.

Bore GW-101 was recorded as dry throughout 2022. Bore GW-101 extends to 12 m depth and has a screen from 9 m to 12 m depth within clay. Bore GW-101 has recorded groundwater levels over 12 mbTOC and noted as dry or having insufficient water to sample since 2013. This may relate to the construction of the bore screen across low permeability clay.

Figure 5.1 Groundwater Levels – West Pit Alluvium

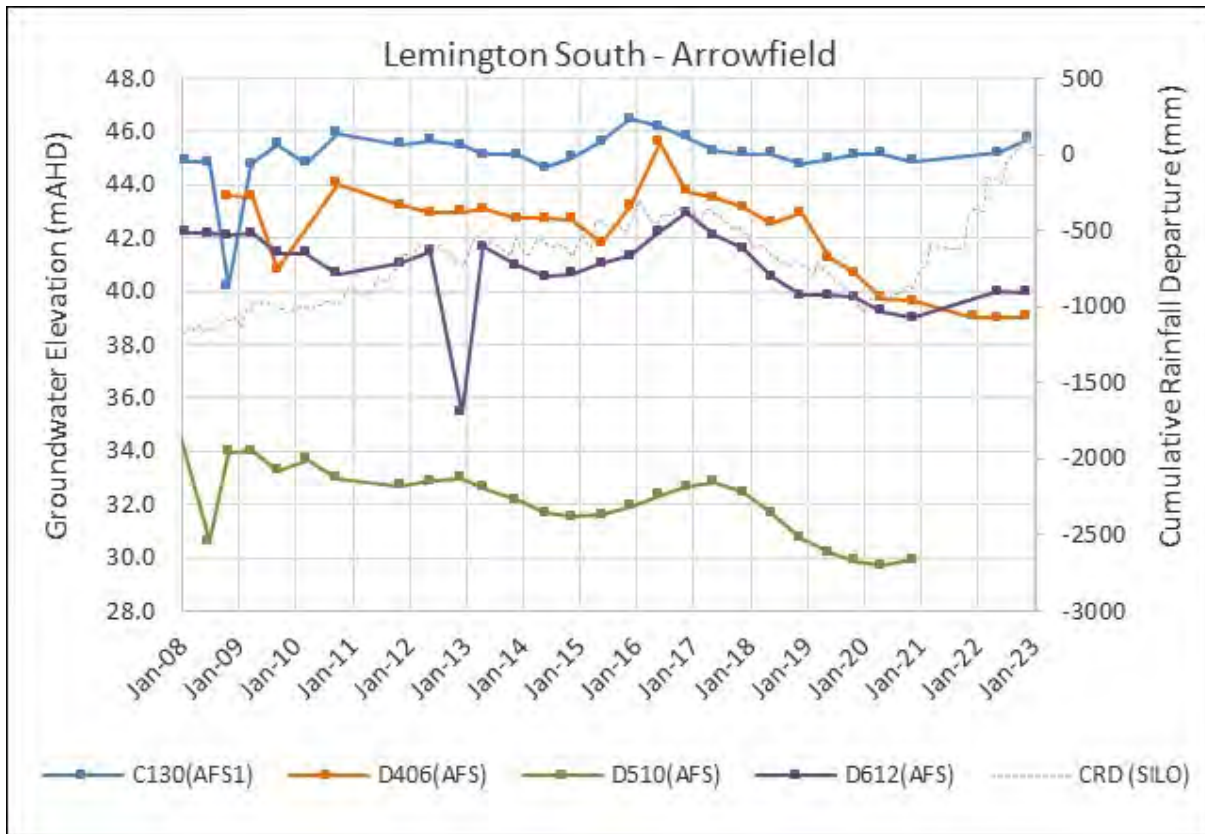
Groundwater level trends for bores targeting the Arrowfield Seam are presented in **Figure 5.20**. It is noted that bore D510(AFS) was recorded as blocked over 2022. Groundwater levels in bores screened within the Arrowfield Seam remained relatively stable over 2022 with only bore C130(AFS1) recording a slight increase of 0.5 m.

Figure 5.20 Groundwater Levels – Lemington South Arrowfield Seam

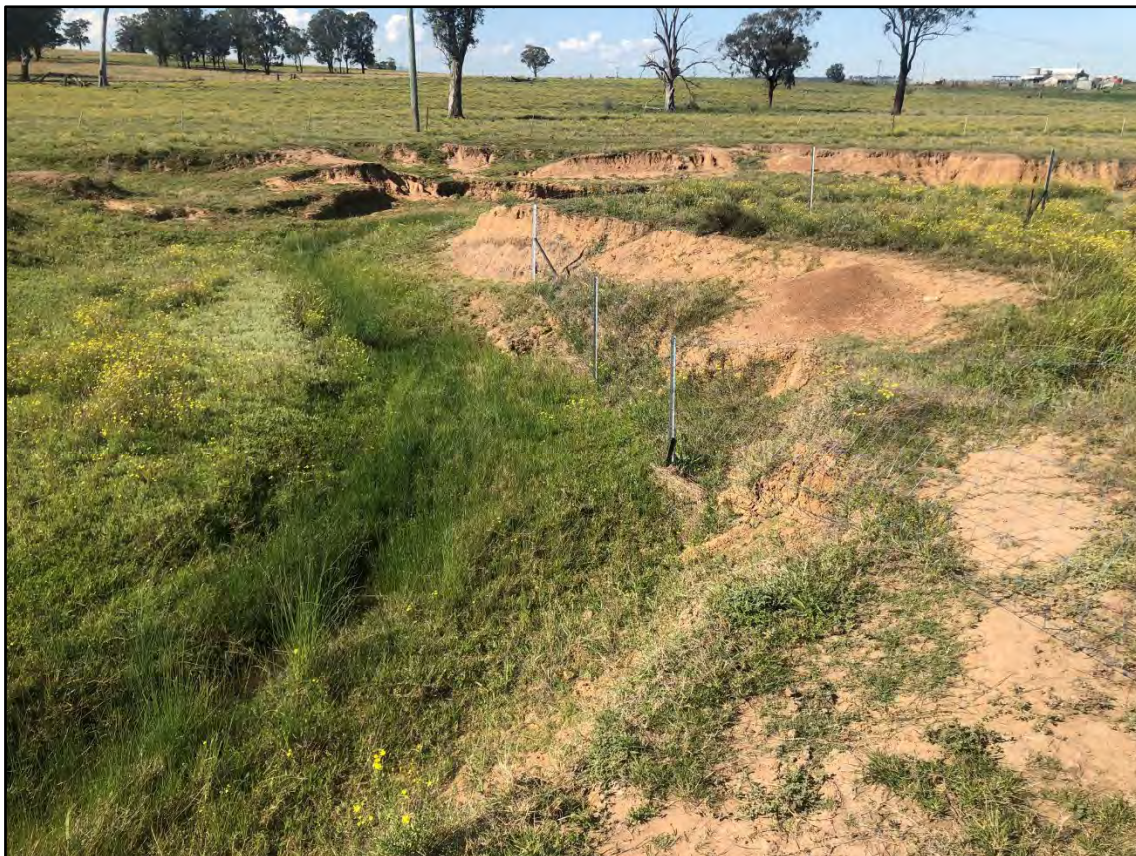
View east across ACH site HVO-35 in August 2020 a few months after fencing installed

Several ACH sites that had been previously hard fenced to protect against livestock impacts were inspected in order to review the effectiveness of this fencing. Several of these sites are located on the edge of an ephemeral gully where erosion and wash had previously been active and where it was considered that artefacts may have been at risk of being lost to these processes. Previous discussions with CHWG representatives had recommended that consideration be given to installing sediment fencing on the downslope boundary of these sites to prevent possible artefact loss. However, during this inspection it was noted that the areas inside these fences had revegetated to such a degree that this ground cover was now providing a stabilising effect in preventing the levels of erosion previously noted at these sites.

The new hard-fencing specification being trialled across HVO has been received positively by CHWG members and is considered the favoured option if potential stock impacts are present. As shown in the photographs below, due to the effectiveness of the revegetating ground cover in reducing or halting erosion impacts, the use of sediment fencing as a further control is now considered redundant. However, this issue should be revisited if vegetation conditions change – i.e. during drought situations.

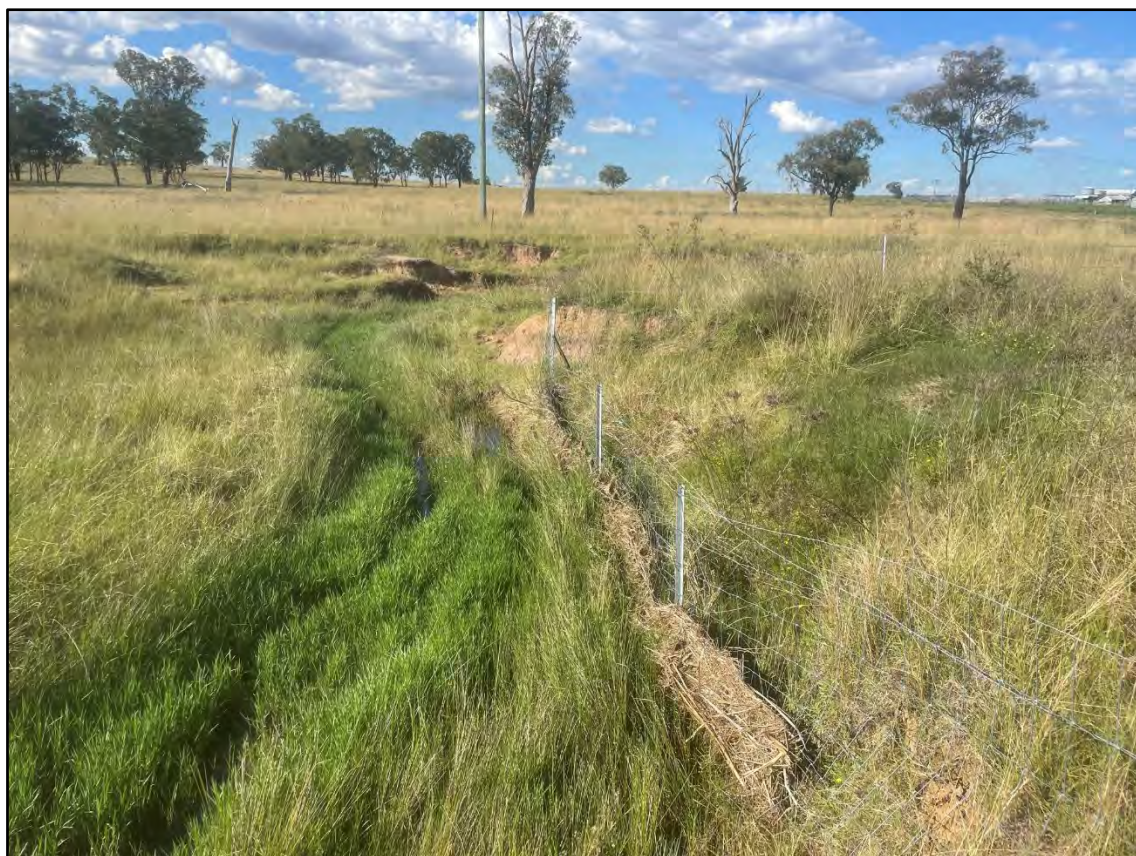
Same view across site in April 2022 showing almost total revegetation
